PLANNING MALAYSIA:

VOLUME 21 ISSUE 2 (2023), Page 275 – 286

DETERMINING THE INTERVENTION STRATEGY FOR HERITAGE SHOPHOUSE FACADES AT IPOH, PERAK

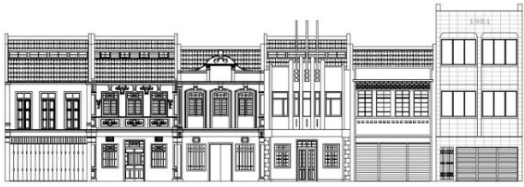
Table 1: An intervention strategy for heritage shophouse facades.

Intervention strategy for heritage shophouse facades at Ipoh, Perak					
Stakeholders		Owner, sponsor, government and non-government bodies.			
Typology		Heritage shophouses			
Existing fabric	Physical characters: Beam, column, roof, wall, door, window, air-vent, fenestration and ornament.

Transitional, Eclectic, Neo-Classical, Art Deco, Early Modern & Modern			
Functional change & potential problems	1)Preserving existing elements 2)Preserving existing elements and adding some new elements 3)New elements Others				
	Potential problems				
	Preservation The shape, colour or material of the elements and structures are in an existing state and well maintained.	Deterioration The elements and structures are in an existing state but affected by fungus, broken, cracked, rusted, faded or vegetation growth.	Replacement Replacing the damaged part of the facade with new elements in existing shape and design.	Redesign Changed shape, colour or existing material to a new scheme.	Others The elements were hidden by signage or vegetation, demolished, new buildings, in-fill, etc.

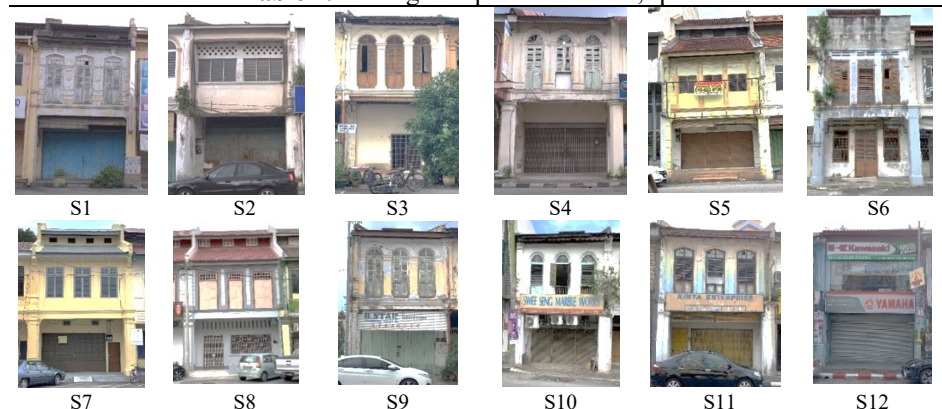
Table 2. Heritage shophouse facades, Ipoh.

The selected heritage shophouse facades in Ipoh are shown in Table 2 and consist of a few architectural styles such as Transitional, Eclectic, Neo-Classical, Art Deco, Early Modern and Modern. Each is coded from S1 to S12. The improper actions are coded from A1 to A6 (see Table 3). There are nine (9) codes for the element of facades. The codes represent; structural (beam and column), enclosure (roof and external wall), opening (door, window and air vent), fenestration and ornamentation (See Table 4).

The condition of each element is evaluated and the result is shown in Table 4. The most affected elements are roof, door, window and wall, due to replacement, deterioration, redesign etc. Eight (8) facades did not retain the original design and material (See Table 5). S12 is the most affected by the improper actions whereby almost all of its elements were intervened followed by S3, S6 and S10. Only S2, S5, S7 and S8 are still above average (50% is considered average) whereby, only three to four elements of the façade have been affected by the improper actions that cause problems.
